Manhole Inspection Summary

Manhole # S31CC1003MH

Insp Date: **10/9/08 2:28 PM**

Location Address: **SAN MARTIN DR**

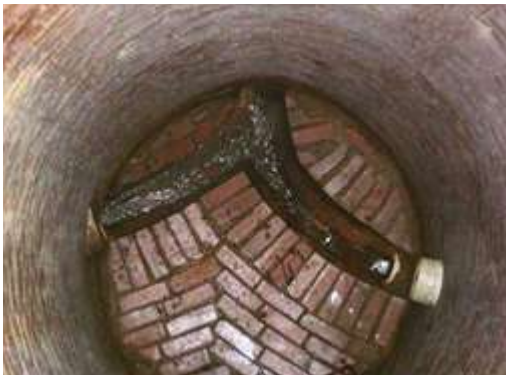
Top View

Bench ☒ Exists Material: **Brick** ☐ Parged ☒ **Debris** (not Condition related)
Condition: ☒ Sound ☐ Cracked ☐ Root Intrusion ☐ Deteriorated ☐ Leaks ☐ Debris

Bench debris.

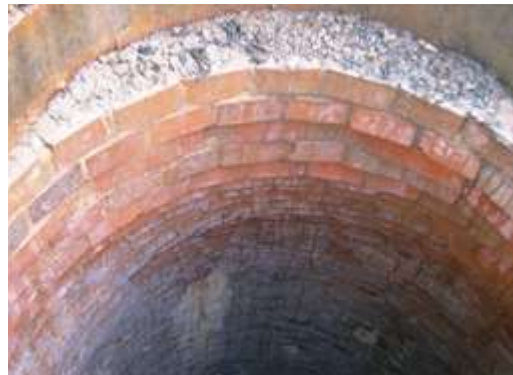
Defect

Frame Offset: **3** (in.) Condition: ☐ Sound ☐ Cracked ☒ **Leaks**

Chimney / Frame Adjustment ☒ Exists Material: **Brick** ☐ Parged Height: **7** (in.)
Condition: ☒ Sound ☐ Cracked ☐ Root Intrusion ☐ Loose Brick ☐ Deteriorated
Infiltration: ☐ None ☒ **Joint** ☐ Cracks ☒ **Mortar** ☐ Roots ☐ Wall

Corbel Material: **Brick** ☐ Parged Type: **Concentric/Eccentric**
Condition: ☒ Sound ☐ Cracked ☐ Root Intrusion ☐ Loose Brick ☐ Deteriorated
Infiltration: ☐ None ☐ Joint ☐ Cracks ☒ **Mortar** ☐ Roots ☒ **Wall**

Frame leaks. Frame offset. Adjustment and Corbel infiltration.

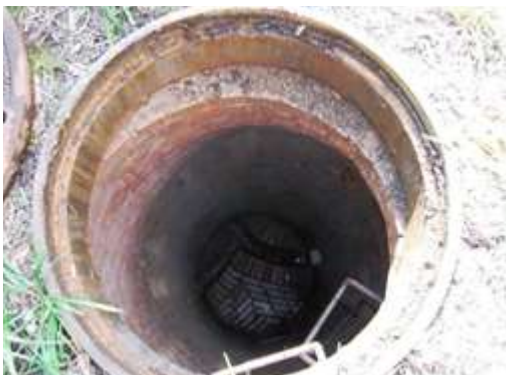
Defect

Barrel Material: **Brick** ☐ Parged
Shape: **Circular** Diameter: **48** (in.) Length: (in.)
Condition: ☒ Sound ☐ Cracked ☐ Root Intrusion ☐ Loose Brick ☐ Deteriorated
Infiltration: ☐ None ☐ Joint ☐ Cracks ☒ **Mortar** ☐ Roots ☒ **Wall**

Frame leaks. Frame offset. Adjustment, Corbel and Barrel infiltration.

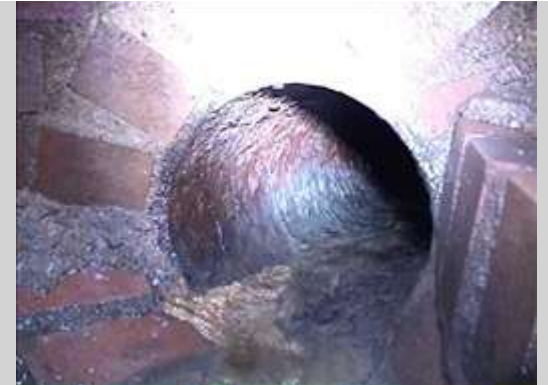
8 in. Circular Gravity Sewer Pipe Out @ 12 O'Clock

Pipe Material: **Clay** ☐ Pipe Lined

Invert Depth: **17.64** (ft.) Flow Characteristics: **Fast**

Deposits: ☒ None ☐ Mud ☐ Sludge ☐ Debris ☐ Grease

Infiltration: **None** Pipe Seal Cond: **Unknown**

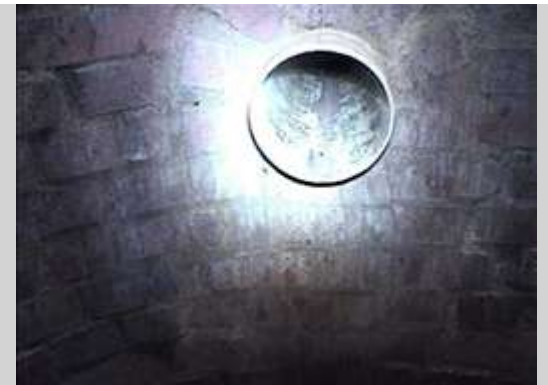
6 in. Circular Gravity Sewer Pipe In @ 3 O'Clock

Pipe Material: **PVC** ☐ Pipe Lined

Invert Depth: **14.54** (ft.) Flow Characteristics: **None**

Deposits: ☒ None ☐ Mud ☐ Sludge ☐ Debris ☐ Grease

Infiltration: **None** Pipe Seal Cond: **Unknown**

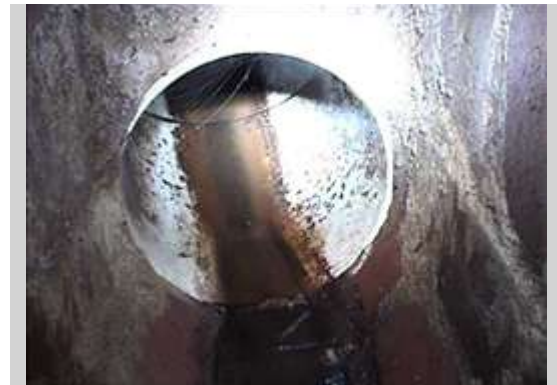
Drop In @ 3 O'Clock

Drop: **Outside** Rod and Bar
Angled: **Yes** Reading: **16.44** (ft.)
Inv Depth: **17.44** (ft.)

Drop Condition: **Open**

Connects To: **House connection / Service line**

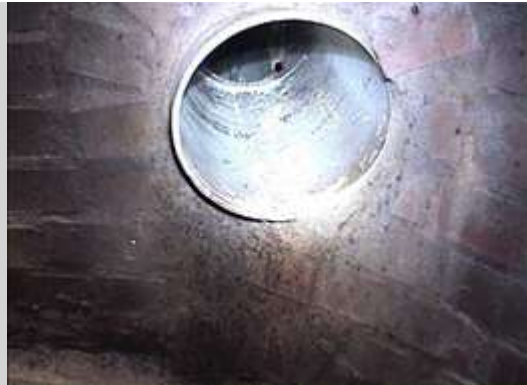
Pipe In @ 9 O'Clock

Pipe Material: **PVC**

Invert Depth: **15.87** (ft.) Flow Characteristics: **Fast**

Deposits: ☒ None ☐ Mud ☐ Sludge ☐ Debris ☐ Grease

Infiltration: **None**

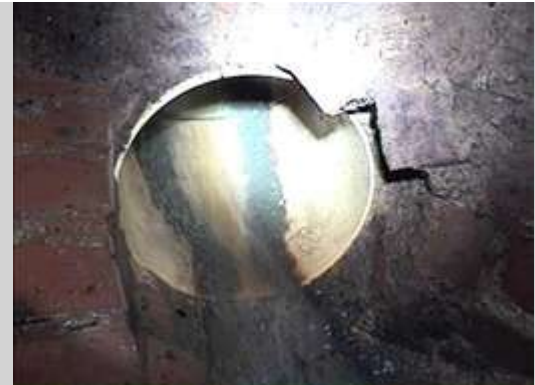
Drop In @ 9 O'Clock

Drop: **Outside** Rod and Bar

Angled: **Yes** Reading: **16.41** (ft.)

Inv Depth: **17.41** (ft.)

Drop Condition: **Open**
